Sunshine Coast Council

Shoreline Erosion Management Plan 2025-2035

Volume 2

Edition September 2024

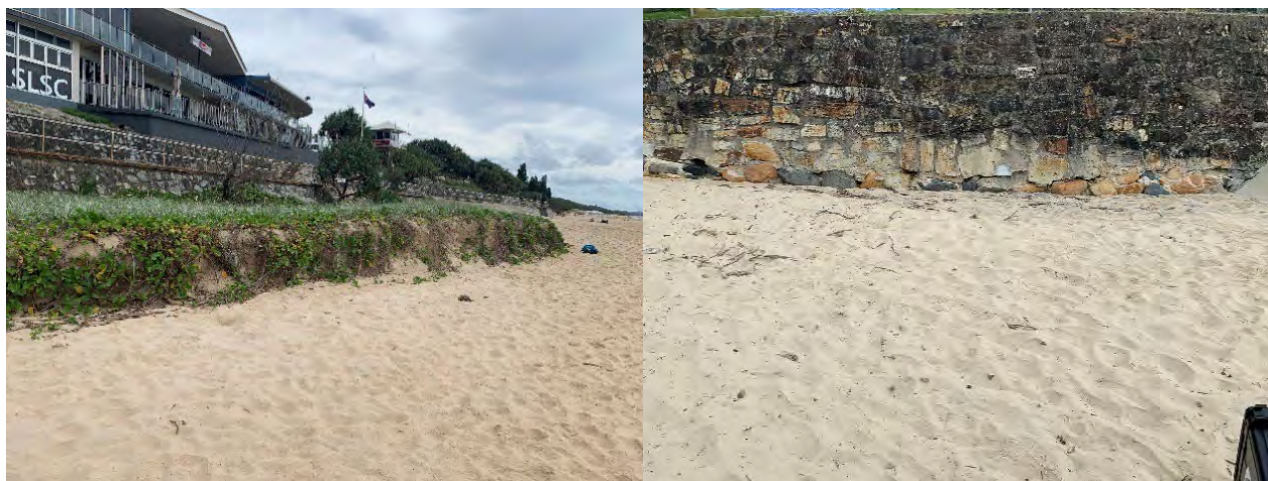
The existing vertical seawall protecting the SLSC has been subject to a visual condition assessment. It has been constructed using grouted rock and extends from Beach Access 77 to Beach Access 81. The general condition is grade 2 to 3 (good to fair), featuring a uniform surface, intact mortar and a buried toe for the majority of the alignment. Observed defects are a loss of mortar at the lower section of the wall. If maintenance activities are undertaken its future renewal is not expected within the lifetime of this SEMP.

Figure 4-2: Left: Transition beach and dune towards the south of the unit. Right: General condition of the wall showing minor loss of mortar (JBP 2023)

- continued maintenance to address the defects observed identified during site inspections;
- if an opportunity arises, new engineering plans for the wall renewal could be developed (e.g., if the adjacent building was to be upgraded). However, this is considered a low priority action given the lifetime of the existing wall is likely to extend beyond the SEMP period;

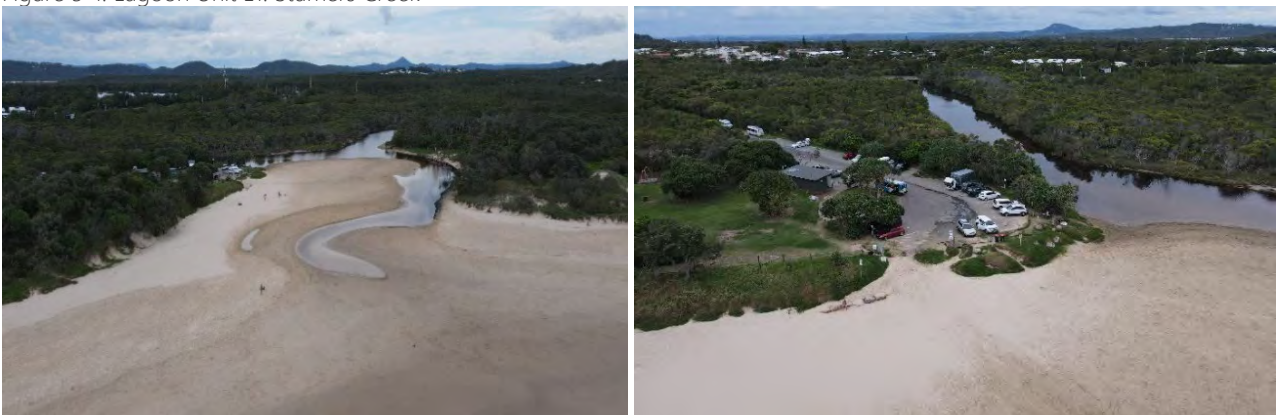
Figure 5-2: Left: Existing condition of the ICOLL entrance. Right: Beach Access 69 (JBP 2023)

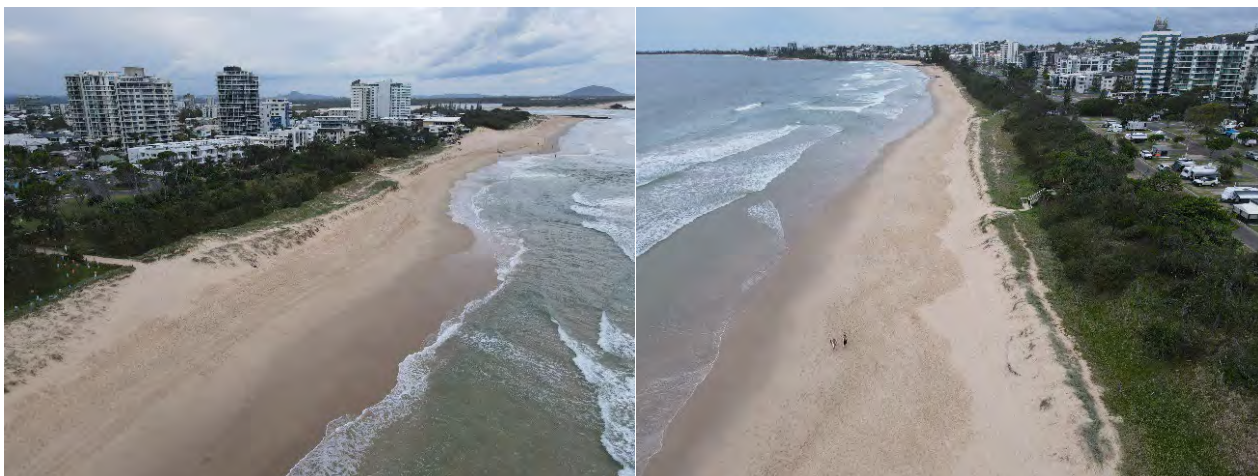
Figure 13-2: Maroochydore Beach. Left: Looking north, showing vegetation and informal access tracks. Right: Looking south, showing informal access tracks (JBP 2023)

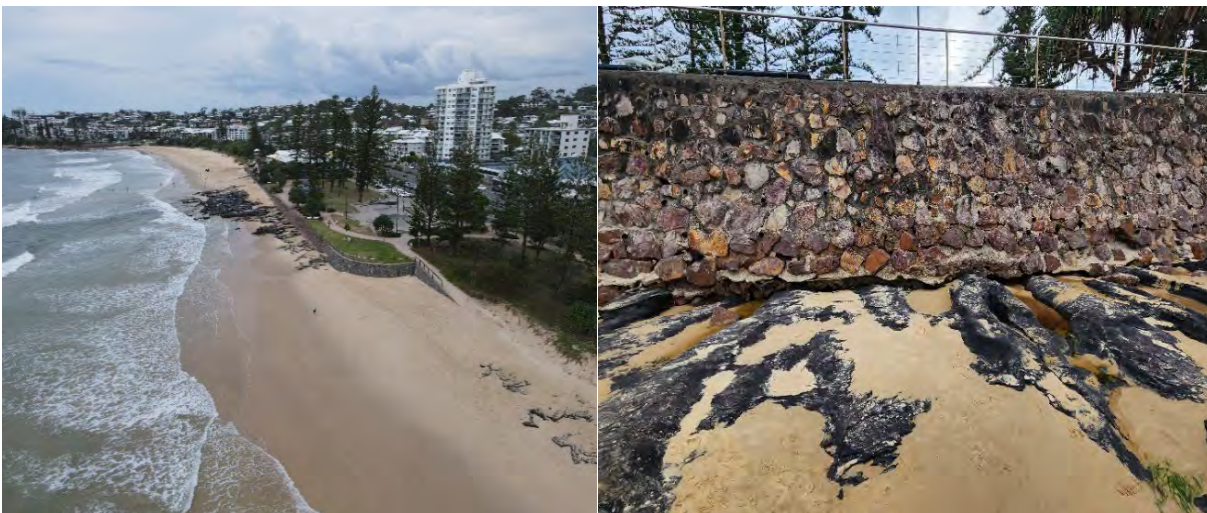
Both seawalls have been subject to a visual assessment to confirm their current condition. The general condition of the main seawall is 4 (poor) with an estimated residual life of 15 years, however the newer northernmost section is in grade 2 (good) condition. It has been partially renewed through ongoing maintenance activities, which are now needed over the remainder of the wall. The primary defect is scouring at the toe, which is leading to the loss of fines underneath the structure and cavities within the wall due to a loss of mortar (See Figure 14.-2). Inspections of the small southern seawall at Alexandra Headland Beach suggest it is also nearing the end of its useful remaining life within the SEMP period.

Figure 14-2: Northern seawall at Alexandra Headland Beach. Left: Skatepark and SLSC looking south. Right: Scouring underneath the seawall (JBP 2023)

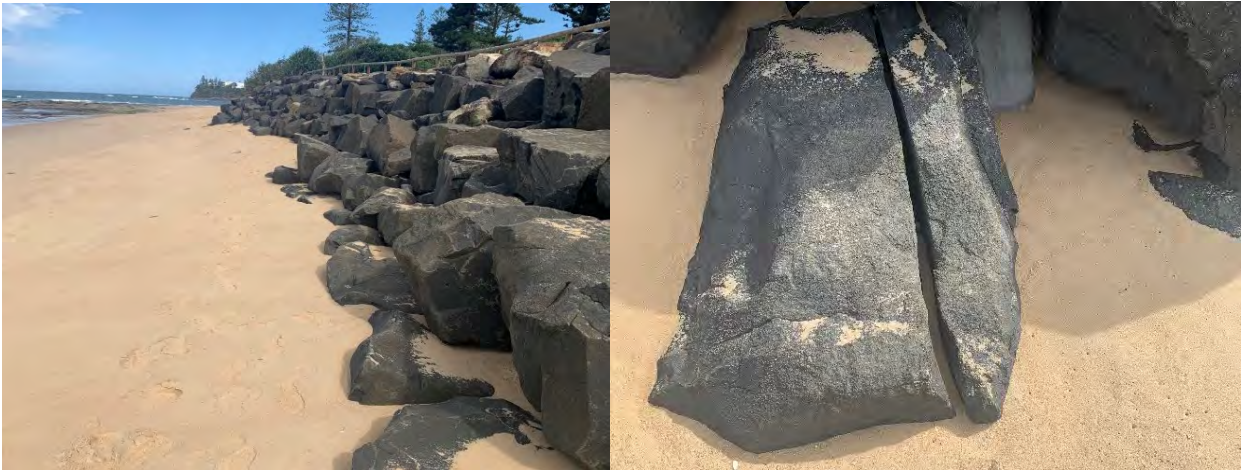
Figure 26-2: Left: Dicky Beach protection structure looking south. Right: Spalling rock (JBP 2023)

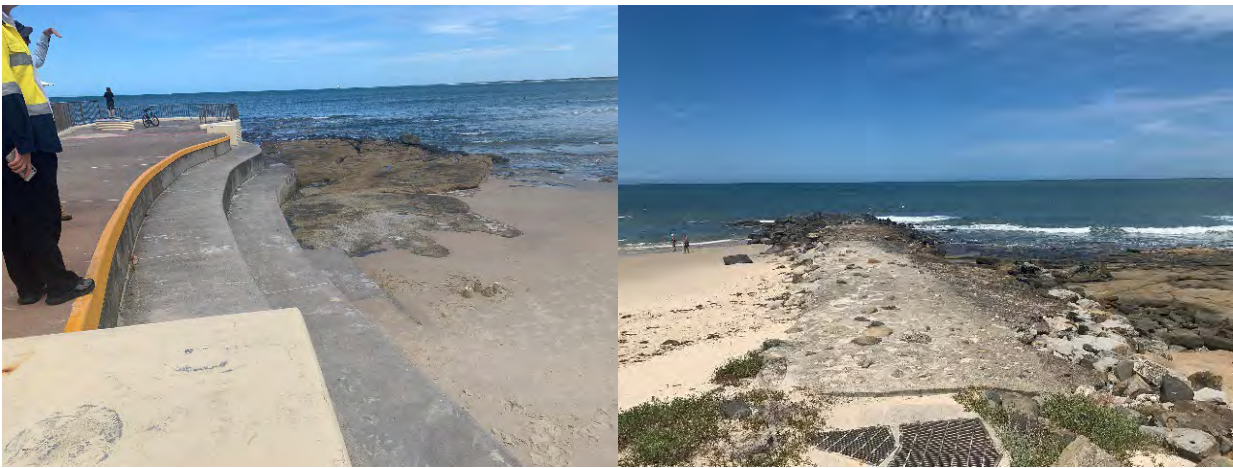
Figure 33-3: Left: General condition of the terraced seawall. Right: General condition of the groyne (JBP 2023)

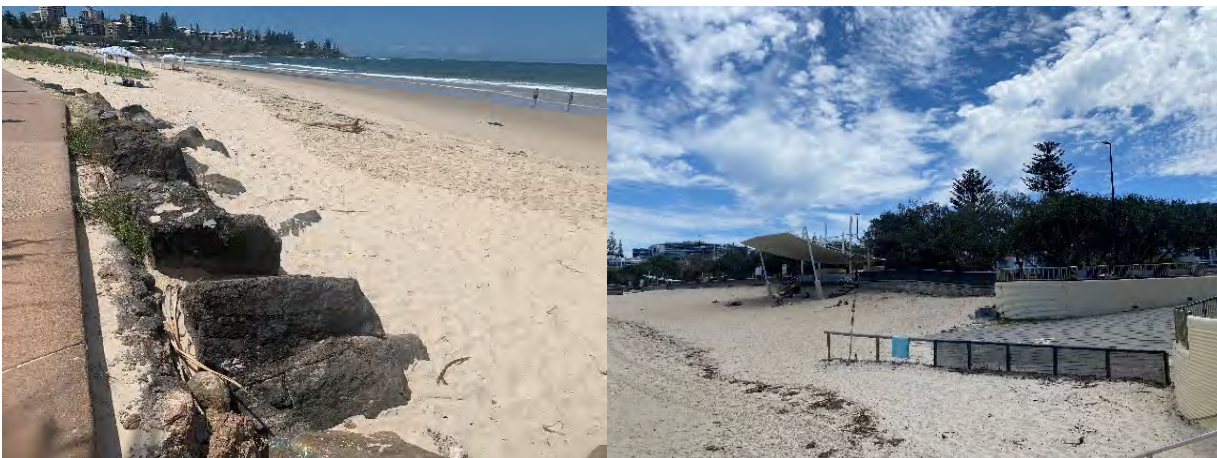
Figure 33-4: Left: Exposed footpath foundation. Right: Beach access ramp (JBP 2023)

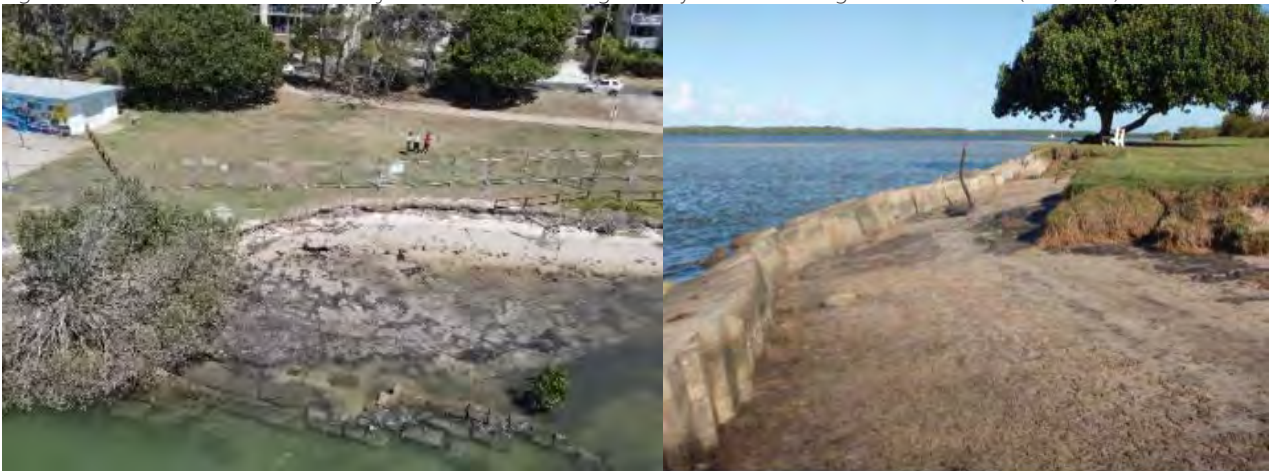
Figure 37-3: Left: Erosion at the failed seawall (JBP 2023). Right: Images of concrete blocks from previous SEMP⁸

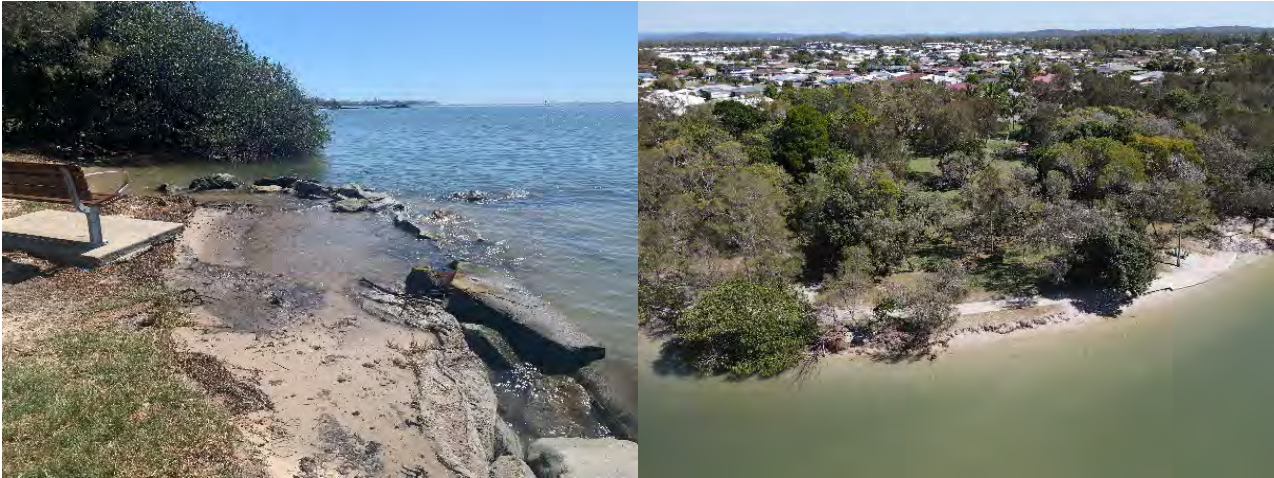
Figure 39-2: Estuary Unit E7. Left: Overtopping and scouring of revetment near Roy Street. Right: Erosion along the shoreline at Bells Creek entrance (JBP 2023)
