Sunshine Coast Council

Shoreline Erosion Management Plan 2025-2035

Volume 2

Edition September 2024

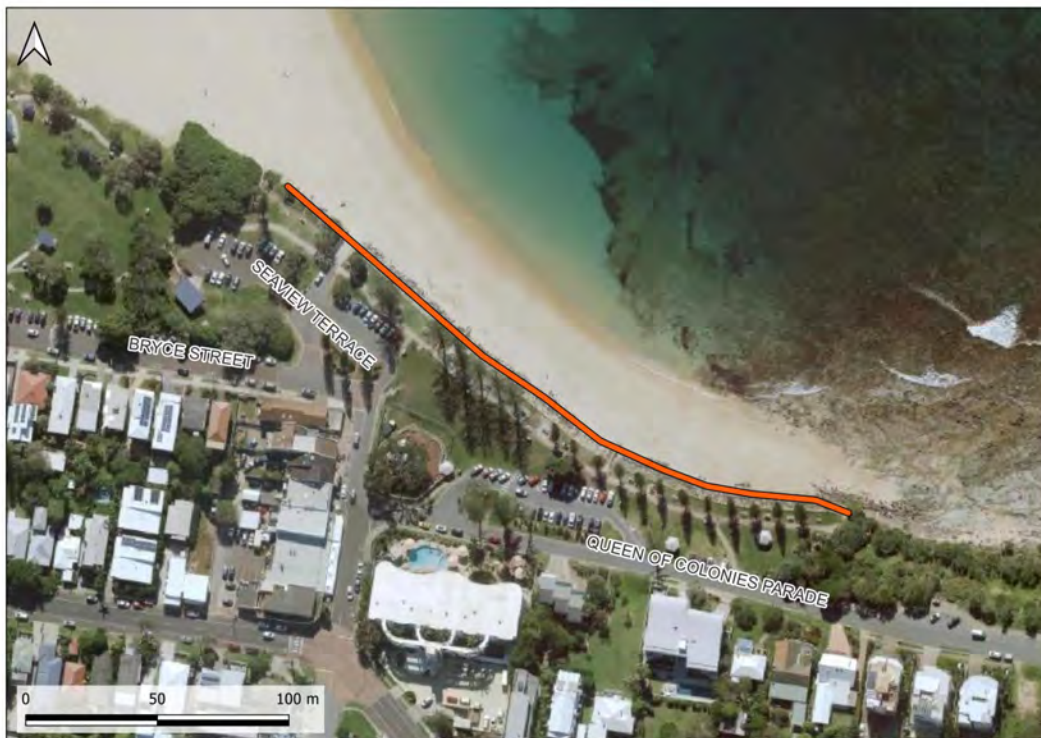
The renewal design would require a review of the existing failure mechanisms, which appear to be through slip circles and sliding, an assessment of re-using the existing rock armour, potentially deepening the toe, tie-ins with the proposed ramp replacement to the west and rock shelf to the east, a designer's risk assessments, statutory approvals and permits, and certification of the design. Consideration should be given to any changes to its alignment due to the existing Norfolk pines.

Figure 29-3: Extent of proposed Moffat Beach revetment after expansion (Unit O16, sub-unit A and B)

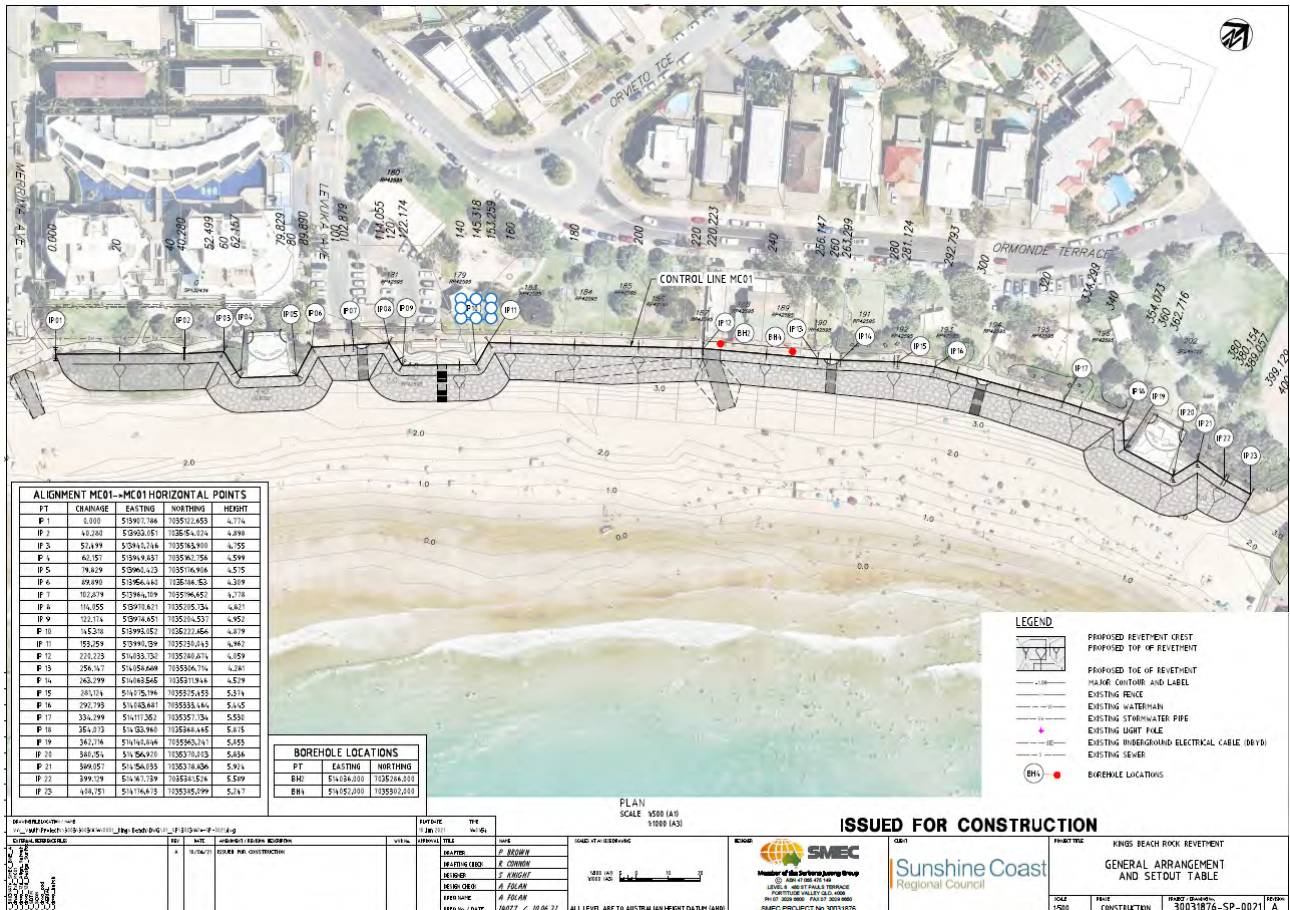
consists of a buried rock revetment with a pitched rock crest with a target rock M50 of 3.5t, placed at a 1:1.5 gradient with concrete infill between the top units to allow capping (SMEC drawing reference 30031876, see Figure 33-2). It extends from Merrima Avenue to the existing concrete wall at the north-eastern end of the beach.

Figure 33-2: Detailed seawall design for Kings Beach from SMEC (2021)

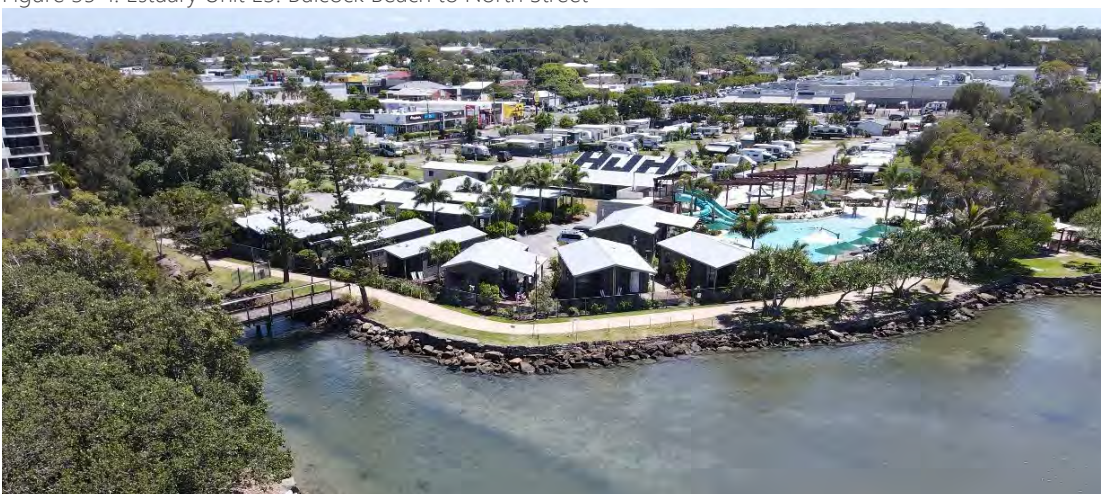
Figure 35-2: The western extent of Unit E3, near Caloundra Holiday Park (JBP 2023)

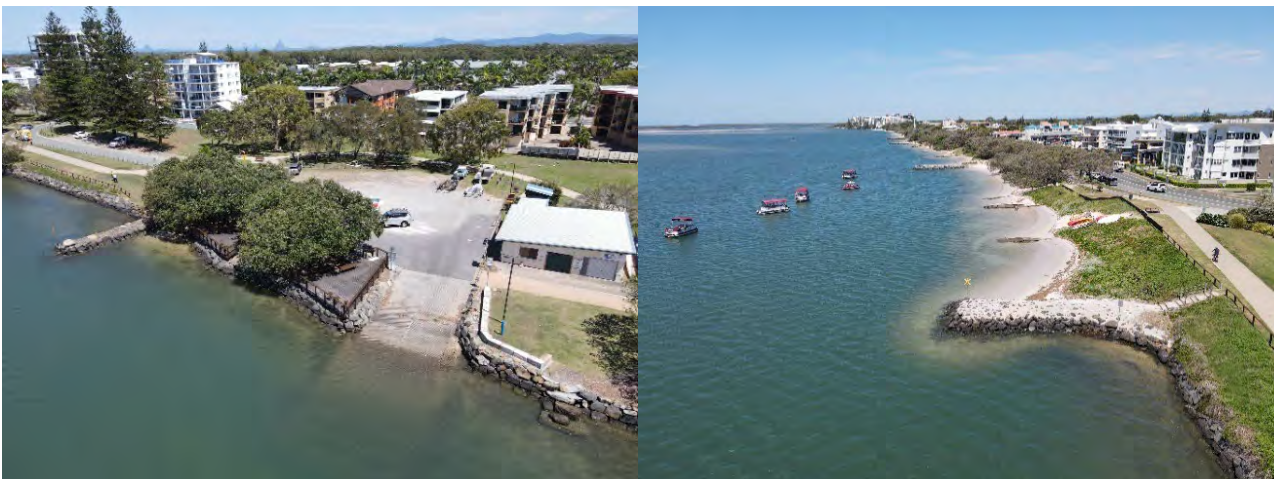
Structural conditions vary throughout the unit and have been reviewed through new inspections and previous reports. The existing grouted vertical revetment wall from Oxley Street to the boat ramp is generally in good condition (grade 2), however shows localised signs of scour at the wall toe, differential settlement, minor rotation, and spalling. Between the boat ramp and the creek near Caloundra Caravan Park, the grouted vertical revetment includes dumped rock along the foreshore which limits toe

observations. The boat ramp is considered to be in good condition (grade 2), with some small defects which can be addressed in future maintenance. The estimated useful residual life of the northern walls and ramp are considered beyond the lifetime of this SEMP (after 2035).

The groyne field begins with a rock groyne approximately 40m south of the Short Street ramp and includes a rock revetment extending approximately 260m. The revetment spans to the second rock groyne, located near Oxley Street. All elements of the initial two rock groynes and the rock revetment are in fair (grade 3) to good (grade 2) condition. They are constructed with large, interlocked rock armour units.

South of the second rock groyne there are 15 additional groynes within Unit E4. Currently (2024) this includes 12 GSC groynes, and three that have been upgraded to rock groynes. The 12 GSC groynes have typical signs of degradation, loss or dislodgement of bags, toe scour, and settlement. The spacing of the existing GSC groynes is considered sufficient, based on the observed shoreline condition, with renewal anticipated to remain within their current footprint.

A jetty is located near the southern end of the unit, opposite the Belvedere Apartments, just north of the Golden Beach Lifeguard Tower at Fraser Park. Overall, the jetty is in fair (grade 3) condition, however, is showing significant signs of marine borers which may trigger early remedial works. This is being addressed initially by installing marine piling tape around the affected piles.

Figure 36-2: Estuary Unit E4 boat ramp, vertical seawall, and groyne structures (JBP 2023)

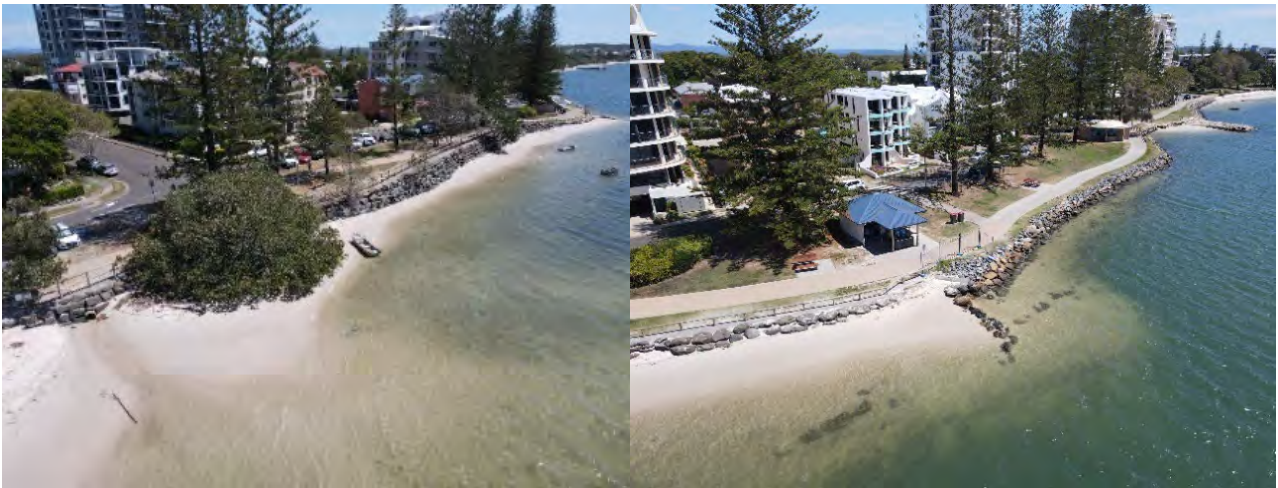
Structural conditions have been reviewed through new inspections and previous reports. The existing rock revetment between Riviere on Golden Beach and Nelson Street is considered to be good (grade 2), having been constructed in 2016. Crest scour and rock top-ups have been noted along the structure suggesting the crest height could be increased (also noting the increased tidal range now affecting the estuary). The condition of the Jellicoe Street groyne is considered good (grade 2), having been completed within the same works package. Both are projected to have a lifetime extending to 2060-2070, beyond the lifetime of the SEMP.

The Nelson Street GSC groyne is in fair to poor condition (grade 3 to 4). It is representative of a mid-life GSC structure, benefitting from being covered by sand for the majority of its length. Its estimated remaining useful residual life is 10 years, which may fall within the SEMP period, depending on the speed of deterioration over the next decade.

Figure 37-2: Left: Northern seawall adjacent to Nelson St. Right: Groyne and beach general condition (JBP 2023)

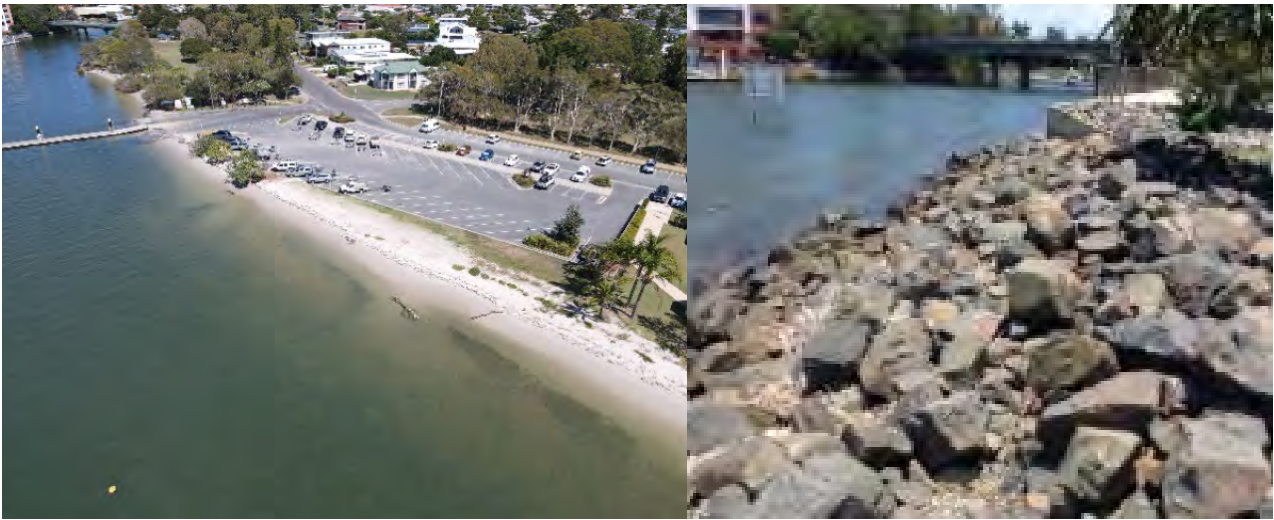
Structural conditions and the general condition of the shoreline has been reviewed through new inspections and previous reports. The condition of the existing rock revetment between the bridge and the canal mouth wall suggests it remains in fair condition (grade 3) with a raised crest supported by established vegetation (see Figure 38-2). No further details could be identified for the revetment, which lacks available engineering plans and may have been part of the original canal development.

The remaining areas of unprotected shoreline are considered to be generally in good condition, free of significant signs of erosion. Consequently, the BIB-PSPD trigger that would initiate the construction of the new revetment is not considered to have been met.

Figure 38-2: Estuary Unit E6 frontage and rock armour (JBP 2023)

New engineering plans would require a review of the existing seawall design, particularly in relation to crest heights and rock armour sizes due to the new hydrodynamic conditions. It would reduce the extent to limit the protection to public assets at Apex Park and the adjacent carpark. Designs would consider tie-ins to the existing infrastructure, designer's risk assessments, updating approvals and permits, and certification of the design. The engineering plans are to include details on the existing structure, alignment, tie-ins, materials, and constructability.
